INSPECTION AND DATA COLLECTION PROTOCOL TO MONITOR PERFORMANCE OF BIOTIC SOIL TECHNOLOGY

Previously published by the International
Erosion Control Association (IECA) as the 2018
“Technical Paper of the Year”

Marc S. Theisen, M.Sc., CPESC, CPSWQ, CESSWI
and J. P. Johns, M.Sc., P.E.

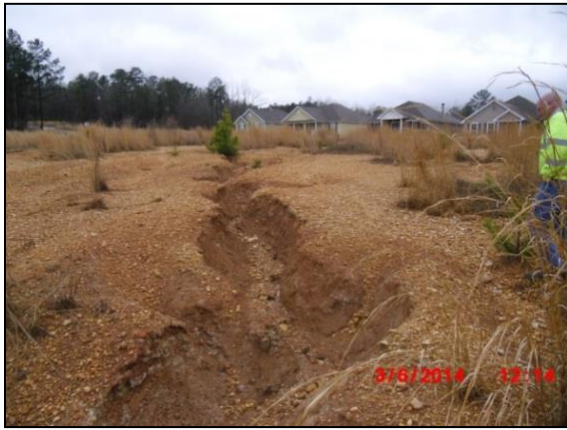
Figure 1 – Denuded and barren site conditions

Soil test results confirmed very low OM ($\leq 1\%$), acidic conditions and a lack of available nutrients to support growth of vegetation. The contractor's first option to improve site conditions was to identify a nearby source of high-quality topsoil to accommodate a 10 cm (4 inch) depth over the re-graded substrate. A second option was to consider using BSTs to add OM, biostimulants and other soil building components directly to the denuded substrate.

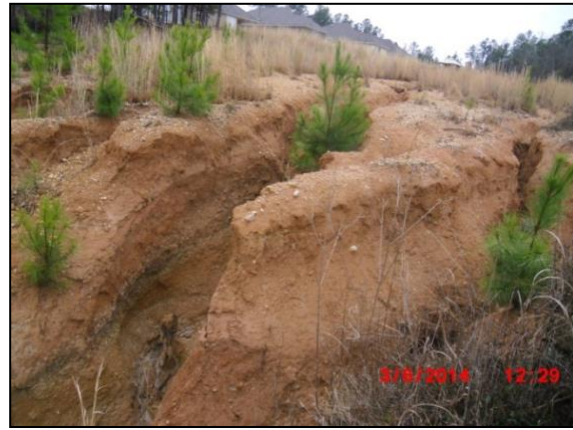
Figure 2 – Acidic soils with low organic matter

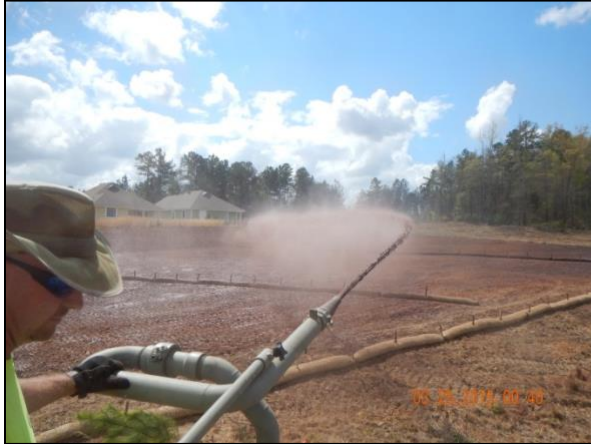
Figure 3 – Application of BST on level areas

Grading of the site substrate to remove gullies, rills and prepare the seedbed commenced in Mid-March of 2015. The flatter areas were leveled and left in a rough condition while the slopes were cat tracked to reduce potential runoff creating pockets and ridges to hold water and seed for quicker growth. Installation of the BST, seed, and soil amendments as well as all erosion and sediment control measures was completed on March 25 in just one day.

Soil amendments included a micronized lime to quickly raise soil pH, 19-19-19 fertilizer with both a fast acting and a sustained release biostimulant. The seed and amendments were applied in the first pass with the BST. The flatter areas were then straw mulched at 4,480 kg/ha (4,000 lb/acre) and then covered with a hydraulically-applied mulch tackifier at 560 kg/ha (500 lb/ac) designed to hold straw and hay mulches in place. The slopes were designed with gradients of up to 3H:1V and an Engineered Fiber Matrix (EFM) was applied at 3,940 kg/ha (3,500 lb/ac) over the BST for additional erosion protection.

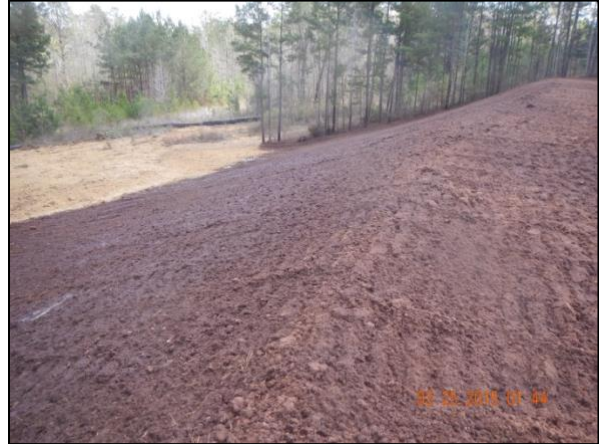
Figure 4 – Cat tracked slope treated with BST

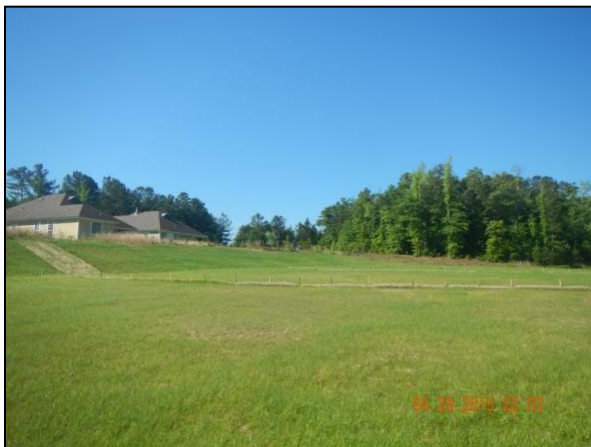
Figure 5 – Growth over “Ghost Clay” on flat areas

Wet conditions prevailed soon after the installations and over the month of April with the site receiving nearly 356 mm (14 inches) of precipitation. Despite the heavy rainfall amounts minimal erosion was observed. Some of the flatter areas were topped with an exposed very light colored, material known locally as “Ghost Clay”, which led to some ponding and overland flow down over the 3H:1V slope. Degradable erosion control blankets were installed with additional seed in two areas where concentrated flow had caused some spot erosion. Meanwhile rapid and dense vegetative growth flourished within 5 weeks as highlighted in Figures 5 and 6.

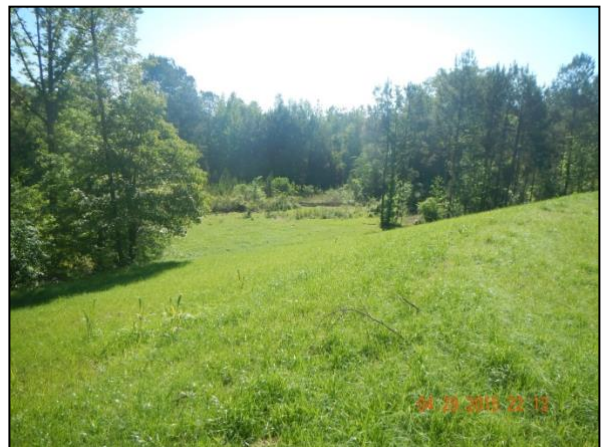
Figure 6 – Luxuriant growth on 3H:1V slope

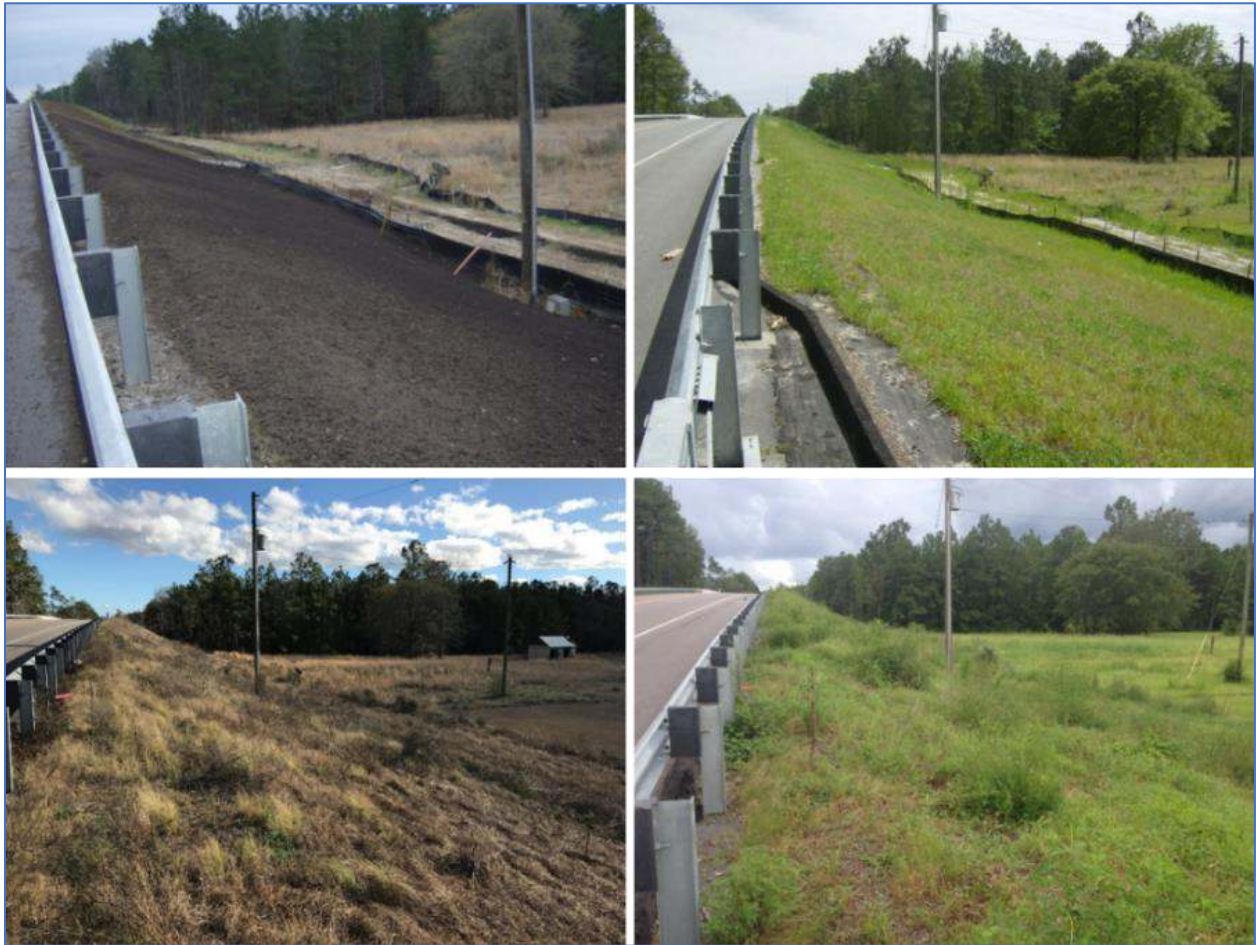
**Figure 7 – Photographs of compost demonstration plot, clockwise from top left:
January 2016, April 2016, September 2016, and January 2017.**

Organic amendments helped establish vegetation and prevent erosion on a site where traditional seeding practices were repeatedly not successful and topsoil was not a feasible solution. Minor rill erosion was observed on the compost plot shortly after the application prior to the establishment of vegetation. Erosion was not observed on the HBSA plots prior to the establishment of vegetation. On all plots, the nurse crop (Rye Grain) emerged in early February and provided a sufficient stand of temporary cover through March and April. This demonstrated that soil amendments are capable of providing rapid growth of temporary cover species even during difficult periods of the growing season.

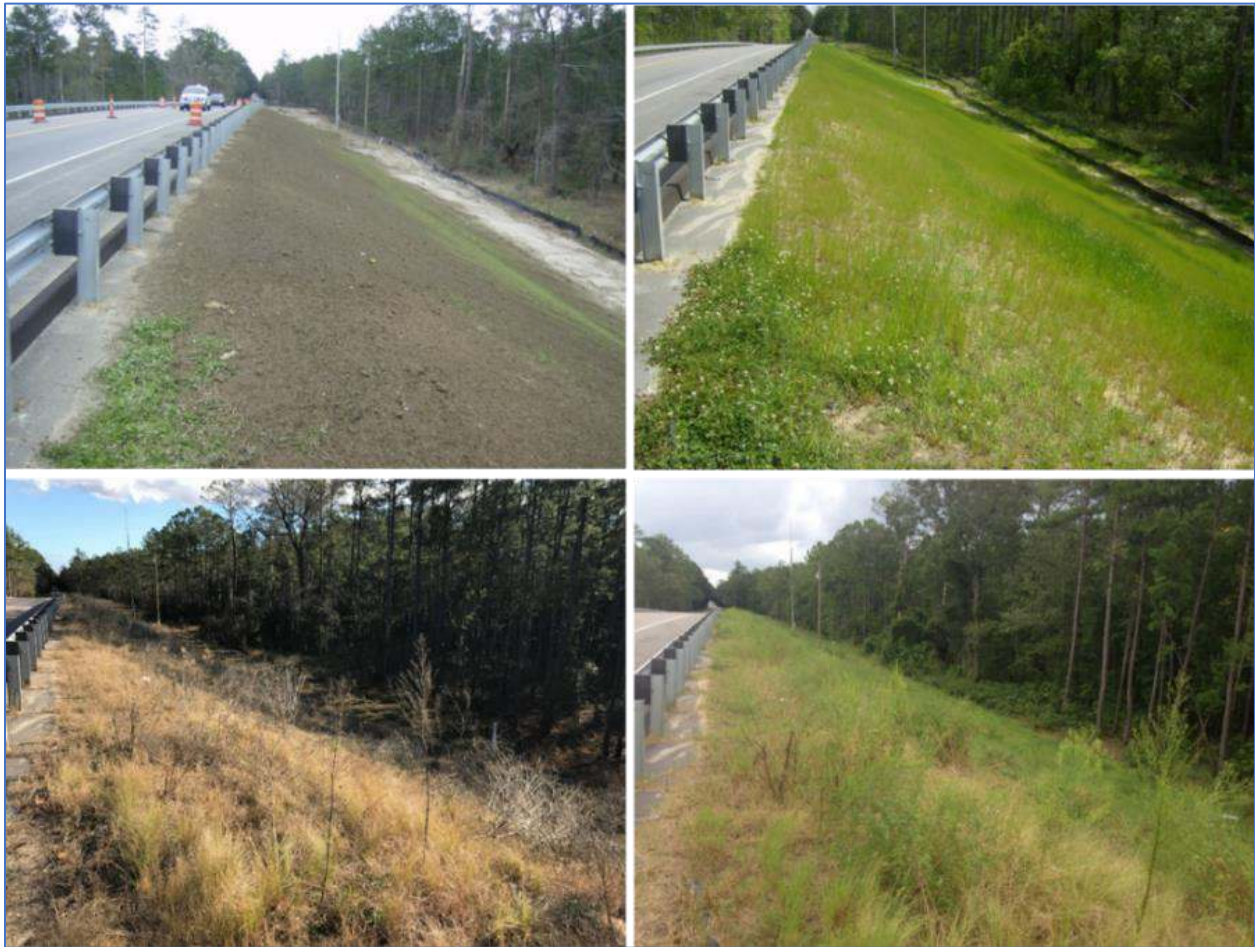
**Figure 8 – Photographs of 1-Step HBSA demonstration plot, clockwise from top left:
January 2016, April 2016, September 2016, and January 2017.**

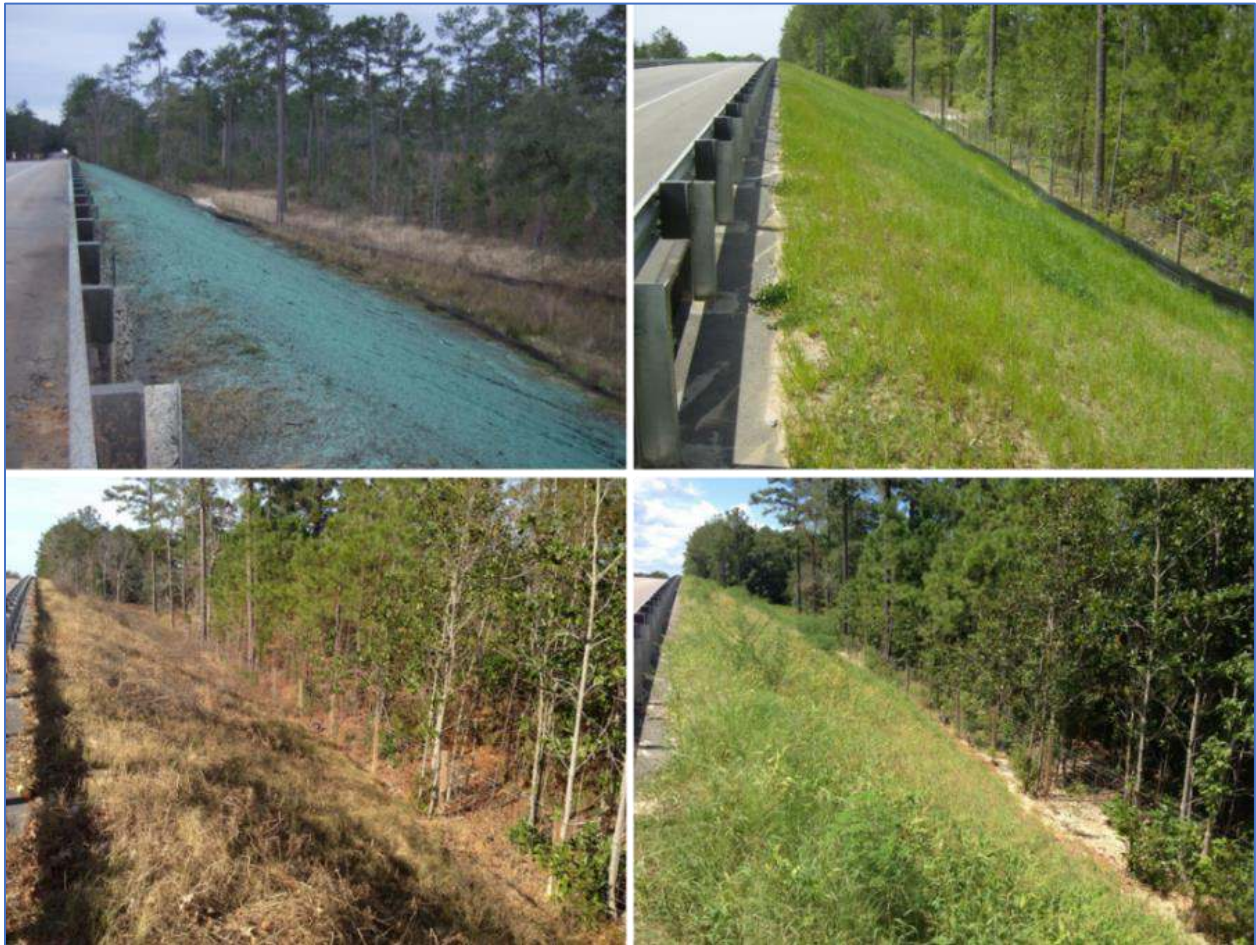
**Figure 9 – Photographs of 2-Step HBSA demonstration plot, clockwise from top left:
January 2016, April 2016, August 2016, and December 2016.**
